**US Army Corps
of Engineers®**

**DRAFT
DETAILED PROJECT REPORT
and
Environmental Assessment
SECTION 1135
Continuing Authorities Program**

**BULL CREEK CHANNEL
ECOSYSTEM RESTORATION
Los Angeles County, California**

June 2005

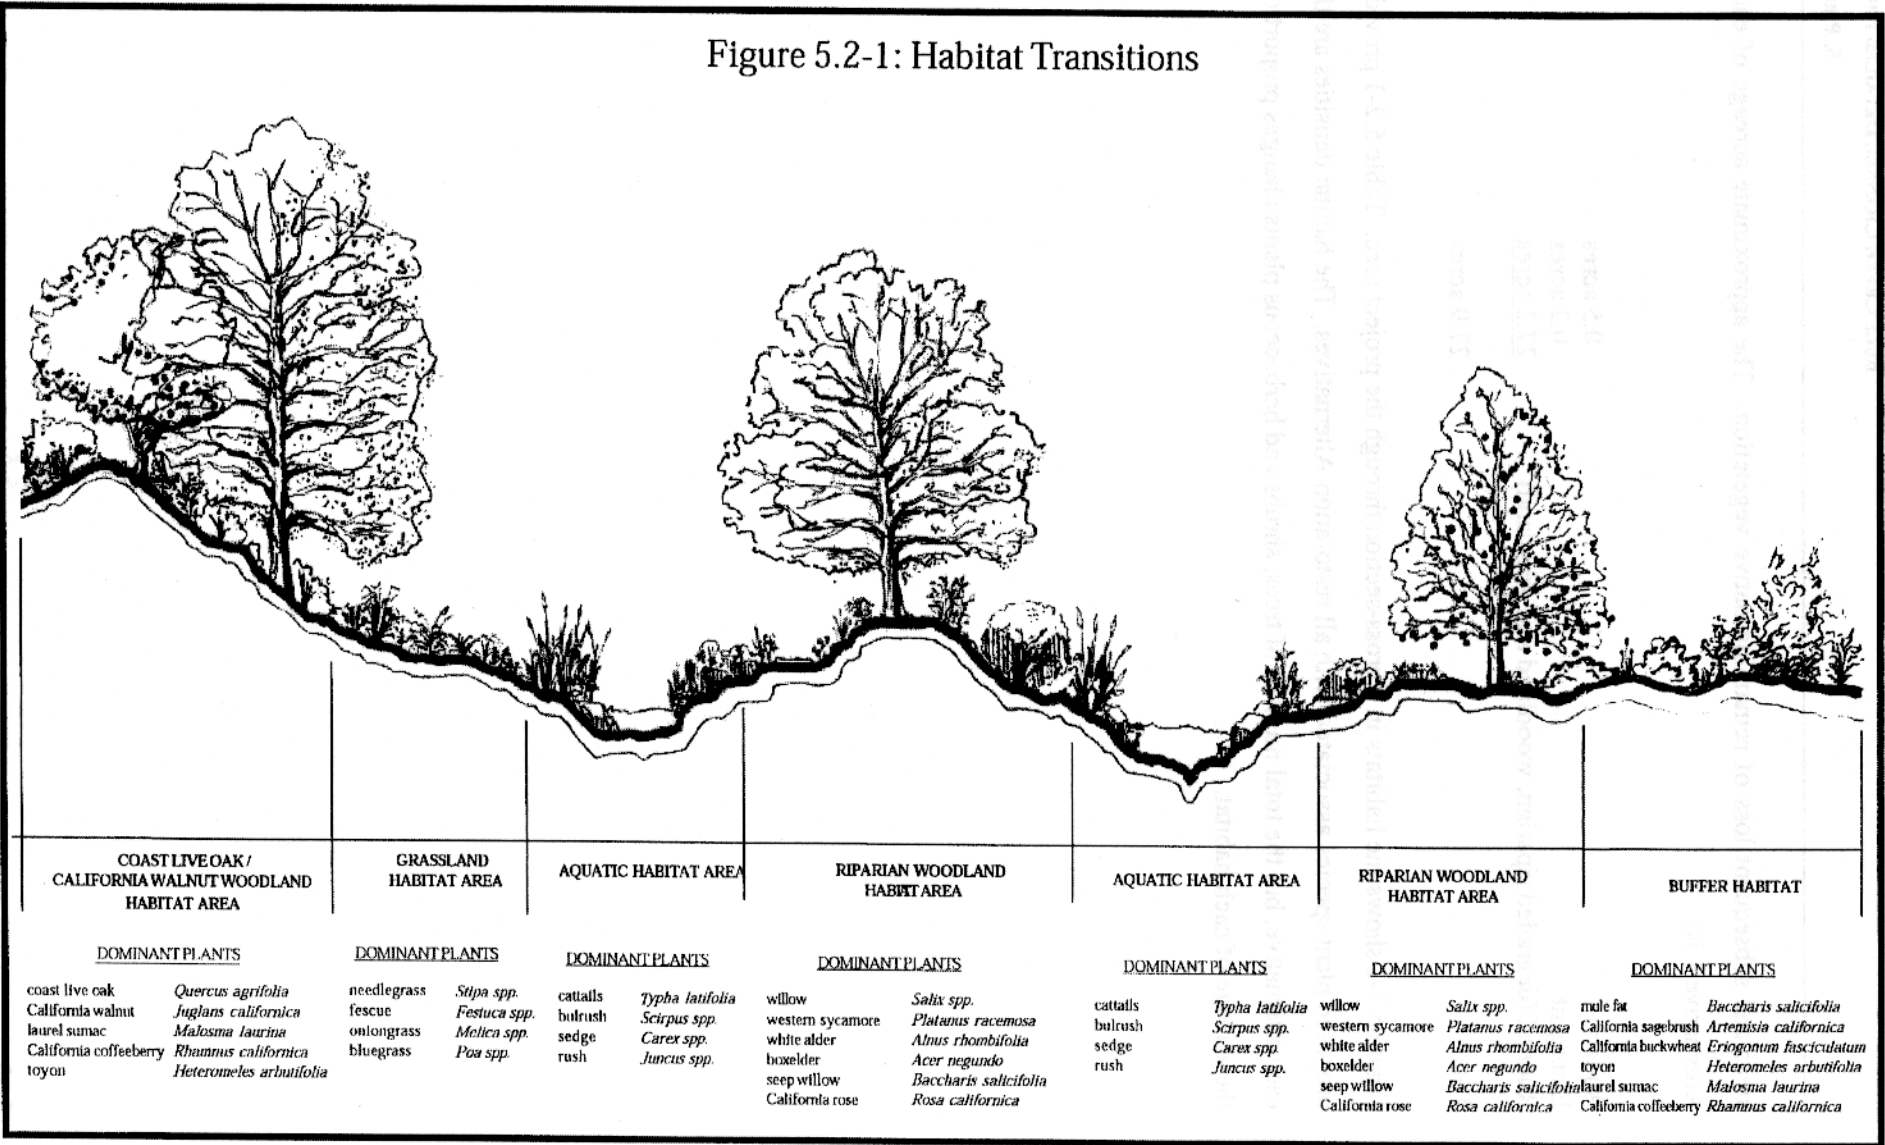
Figure 5.2-1: Habitat Transitions

Figure 5.2-1 shows the habitats in a cross-section through the project area. Table 5.2-1 provides the proposed plant species associated with all restoration Alternatives. The habitat densities are the same for each alternative, but the total number of trees, shrubs and herbaceous plants changes proportionately with the acreage of each habitat.
